ENVIRONMENTAL PROBING INVESTIGATIONS, INC.

SUBSURFACE SURVEY REPORT

DATE	January 6, 2018	CLIENT	
WEATHER	Sunny, 20s	PROJECT NAME	
EPI Geophysicist	Paul McLeod	PROJECT ADDRESS

Environmental Probing Investigations, Inc. (EPI) was contracted by to locate utilities and investigate areas of concern surrounding a bus service building.

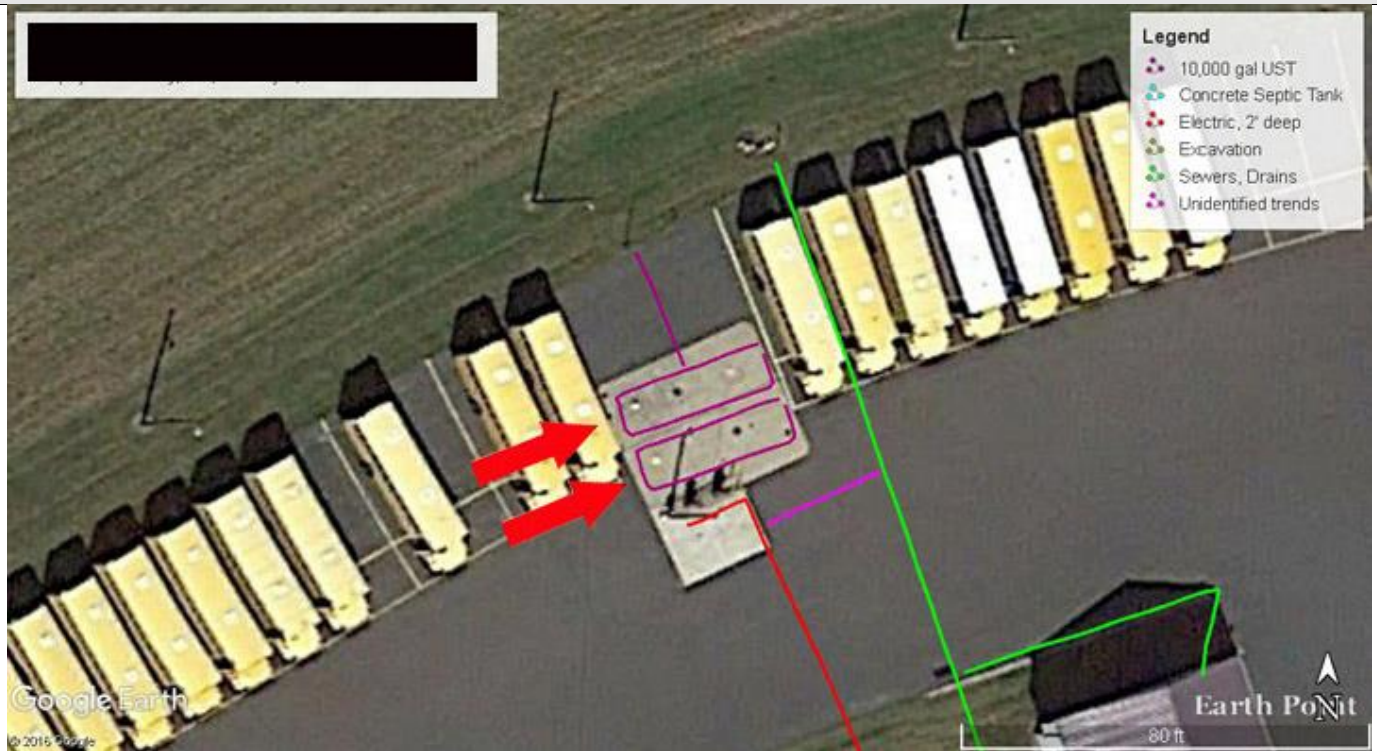
PHOTO 1

Two 10,000 gallon USTs sit to the north of the fueling island. Each measures 27' x 8' and their tops sit 3' below surface. A pair of vent pipes is mapped to the north of the tanks. A buried electric line leads from the building to the fueling island and is mapped in red. This line was detected with both GPR and line tracing. GPR work was conducted around the fueling island to search for graves or excavations related to earlier USTs, but no graves were detected.

The arrows point to the two 10,000 gallon USTs which measure 27' long and 8' wide. A pair of vent pipes sits at the contact between the asphalt and the grass. Electric power to the fuel island is shown in red and arrives via a buried line from the building.

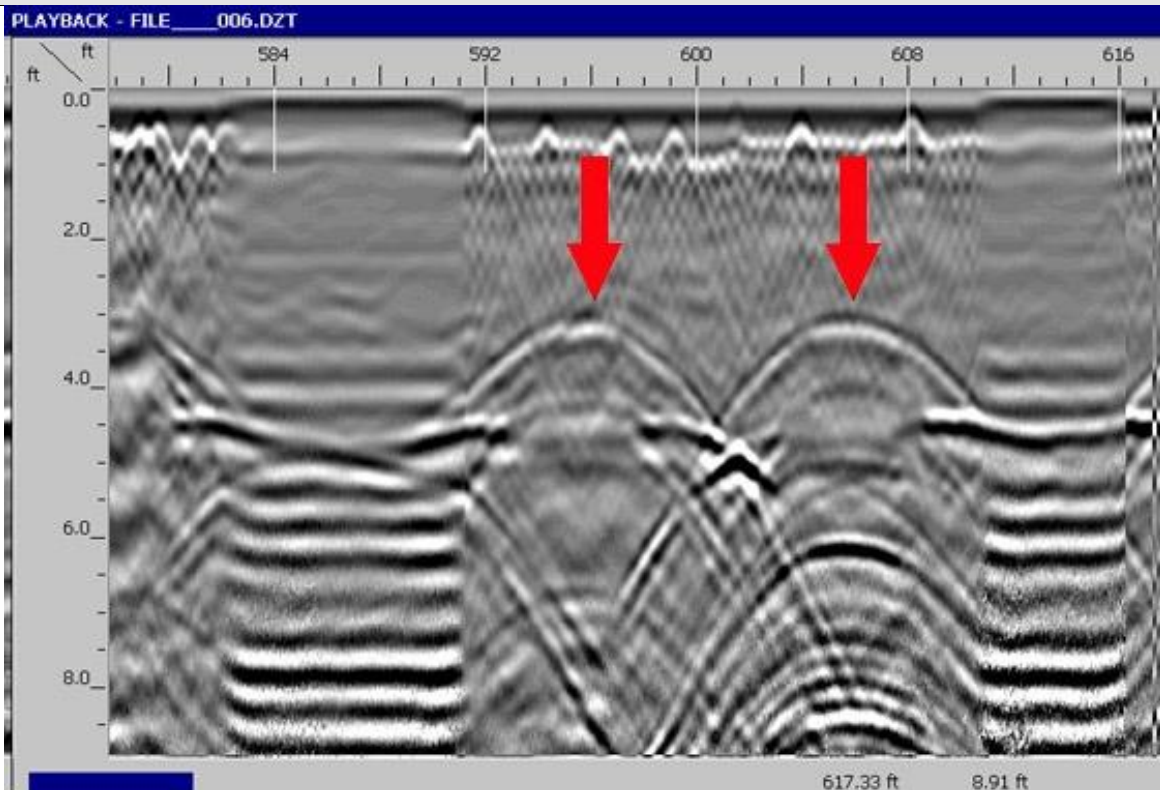
PHOTO 2

GPR transect across the two USTs shows that the tops of those tanks sit at a depth of 3' below surface.

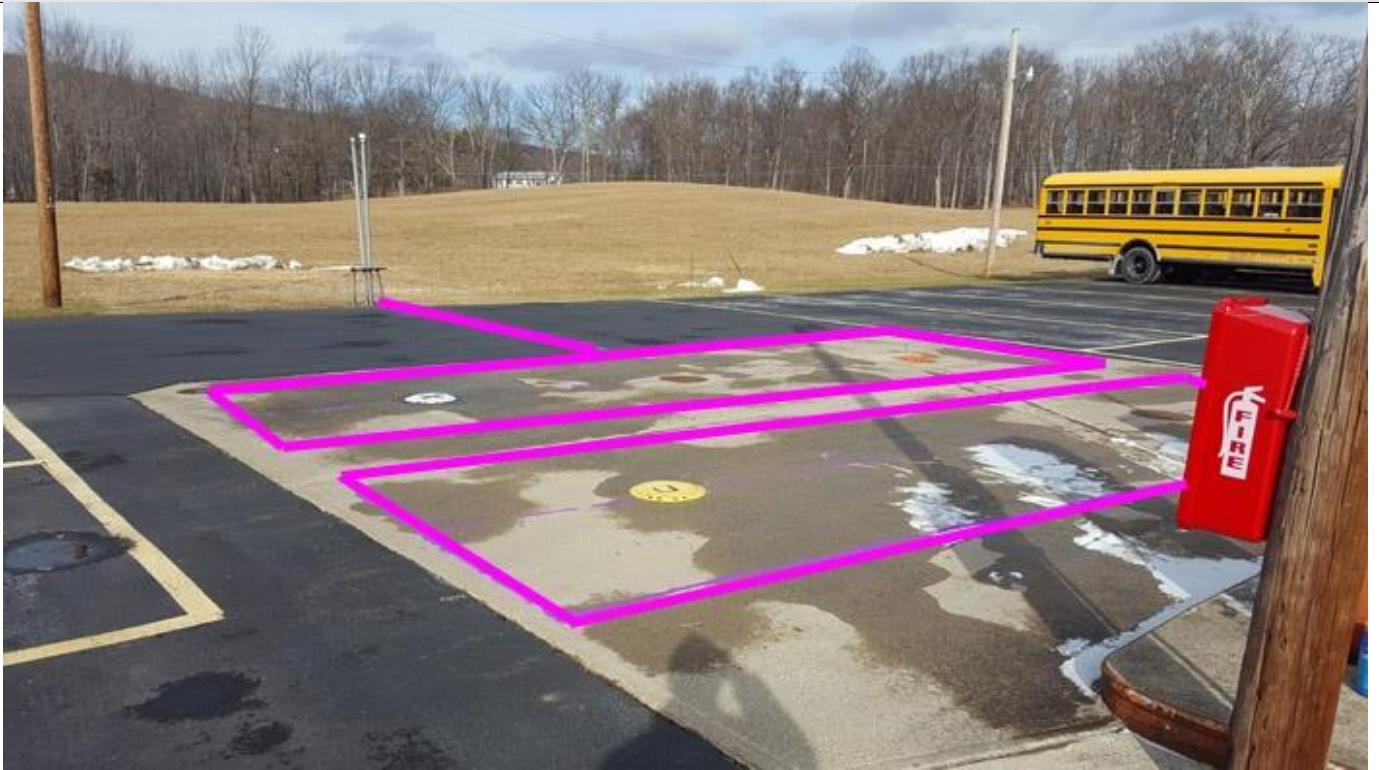
PHOTO 3

Northeast facing photo shows the outlines of the two 10,000 gallon USTs. The tanks each measure 27' x 8'. The vent pipe is visible behind an perpendicular to the tanks.

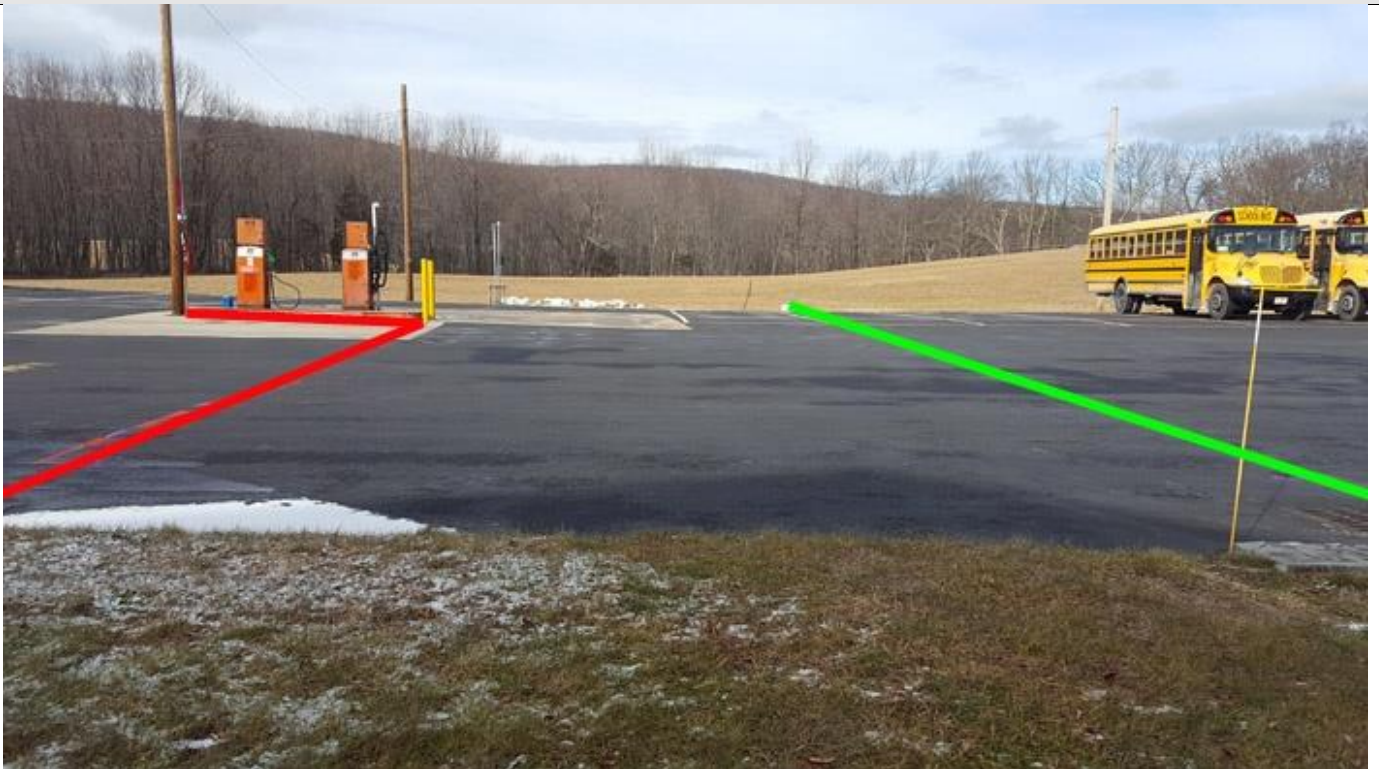
PHOTO 4

Northwest facing photo of the fueling island area as seen from near the building shows the electric line in red and a storm sewer in green.

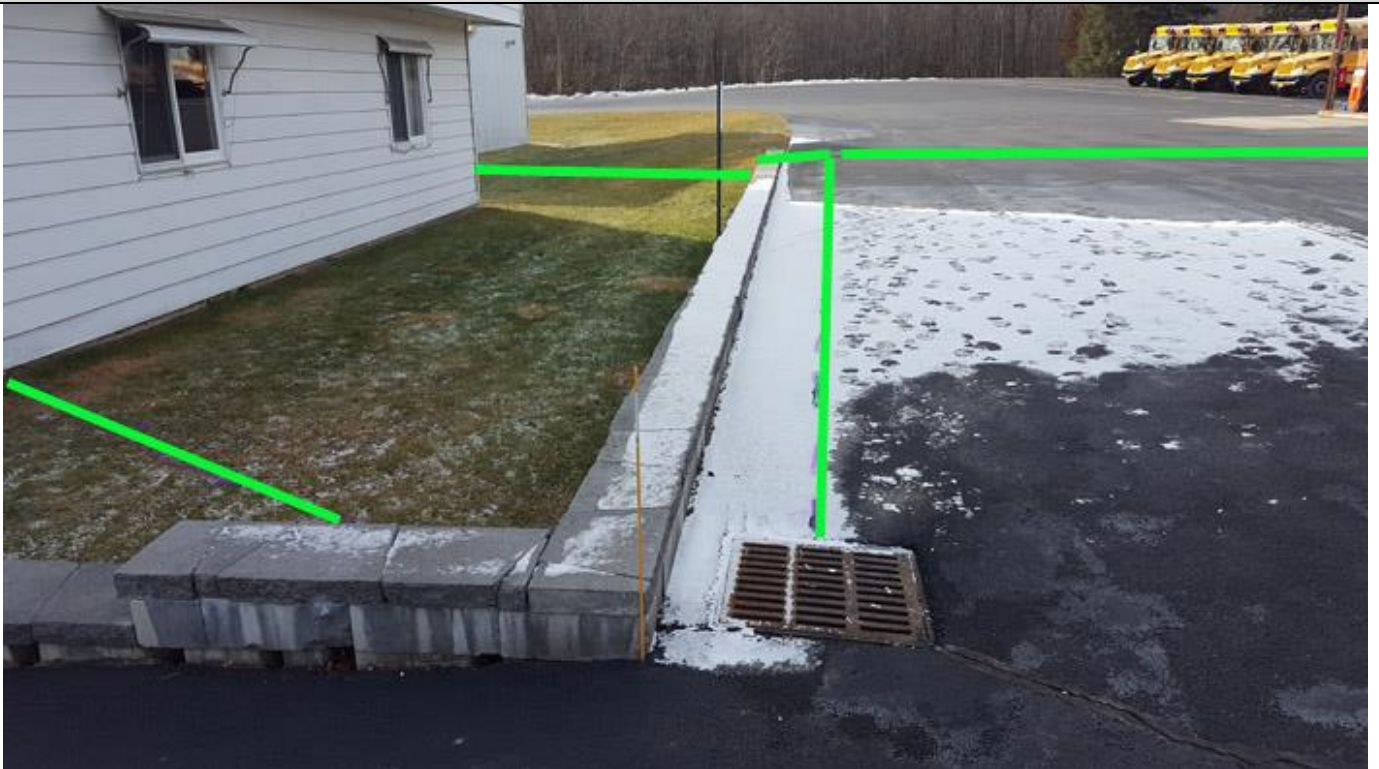
PHOTO 5

Southwest facing photo shows a series of storm sewers and drains in green.

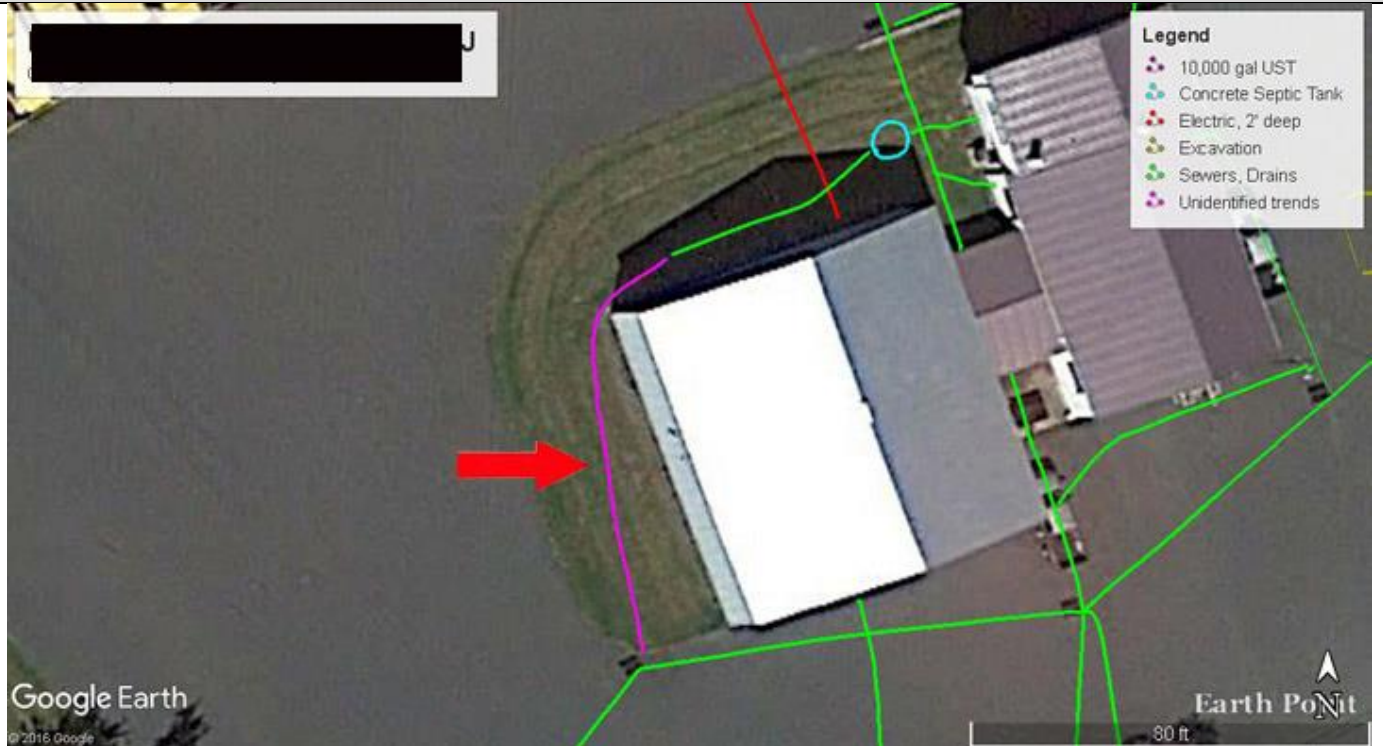
PHOTO 6

Storm sewers and smaller drains were documented all around the building and mapped in green. The larger sewers sat at depths of 3-5' while the smaller gutters and drains sat at depths of 1-2'. These were all mapped with GPR. The septic system behind the building consists of a cylindrical concrete tank approximately 6' in diameter. The tank is fed by a short line at a depth of 3' which also features a clean-out adjacent to the building. That line enters the tank on its east side. A PVC lateral sitting at a depth of 3' exits the tank on its west side. an employee who watched the installation of the system reports that the PVC pipe sits in a gravel-filled trench. GPR data suggests that the lateral ends near the NW corner of the building but that the gravel-filled trench continues along the west wall of the building and connects to a storm sewer system near the SW corner of the building.

Sewer and drains surround the bus service building. The circle near the northeast corner of the building is a concrete septic tank, and the green line to the west of the septic tank is a PVC lateral. The purple line indicated by the arrow appears to be a gravel-filled trough allowing the filtered wastewater to drain into the storm sewer.

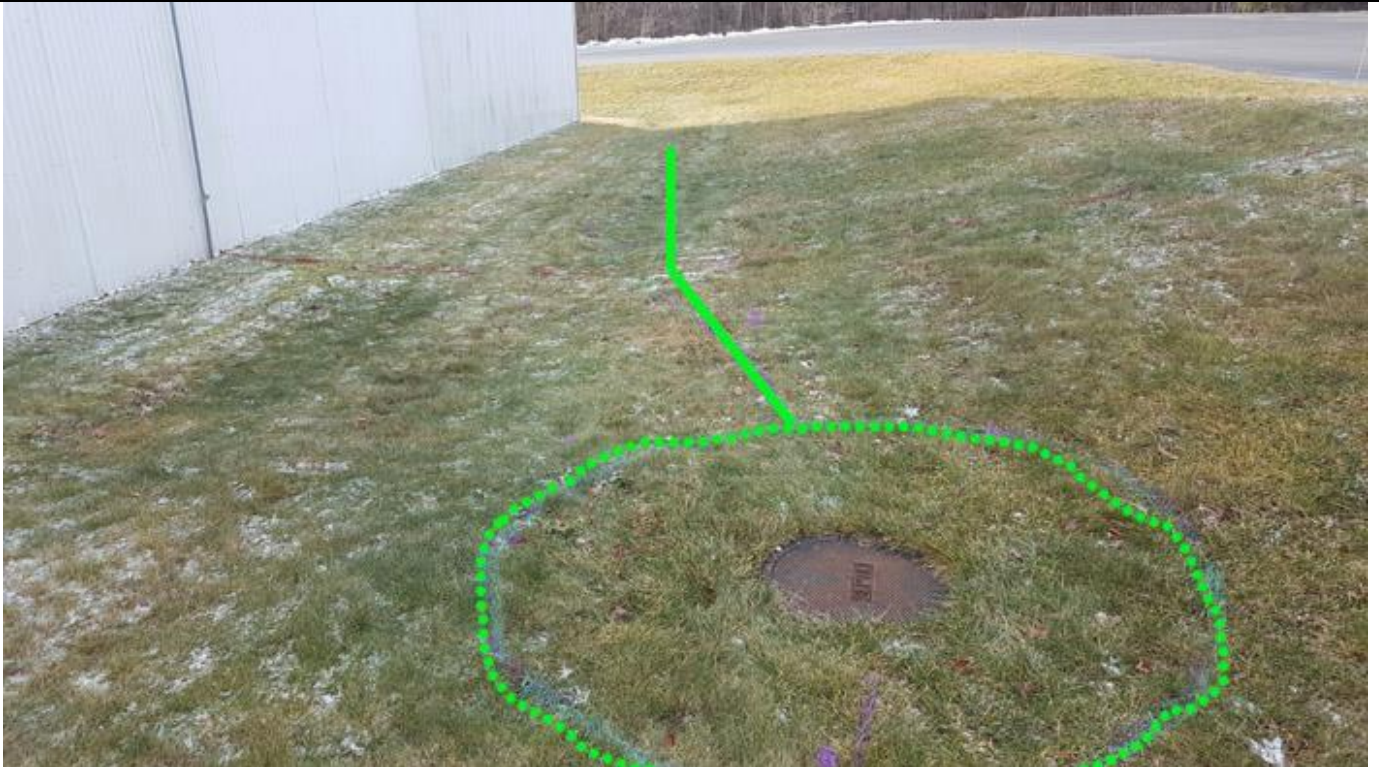
PHOTO 8

Southwest facing photo shows the circular concrete septic tank and the lateral PVC line that leads away from it. The lateral coincides with a topographic trough which is apparently filled with gravel.

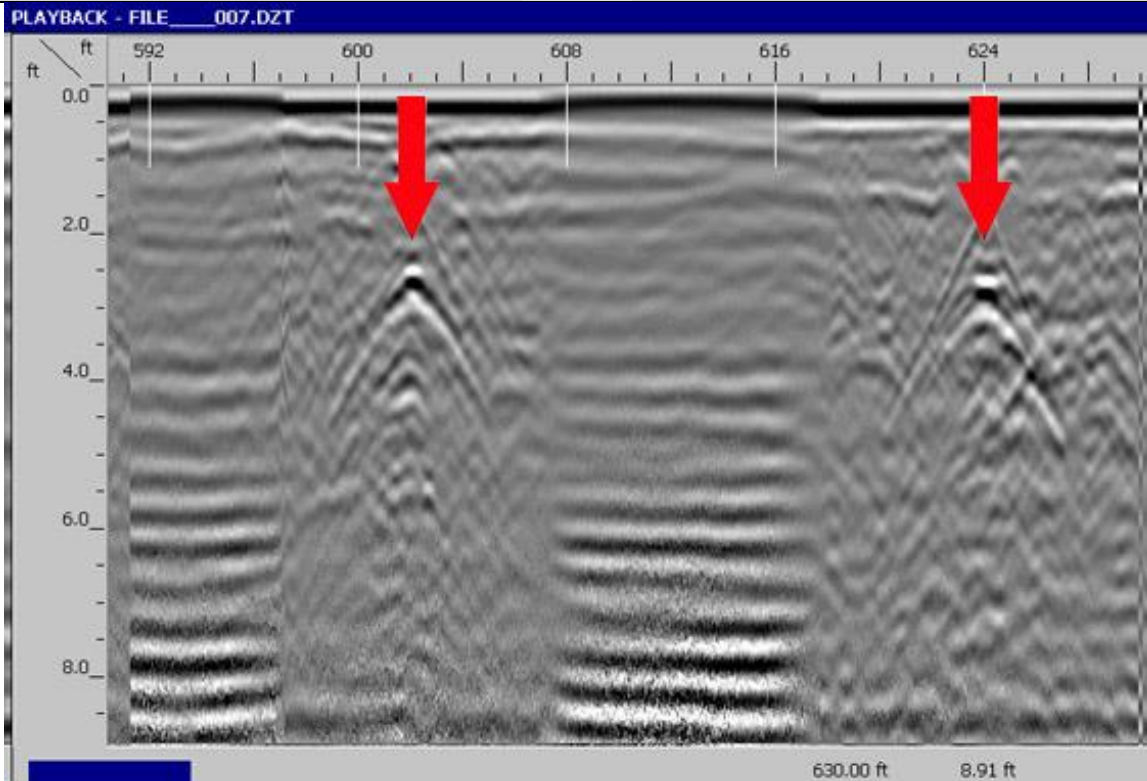
PHOTO 9

GPR transects across the PVC lateral shows that the lateral sits at a depth of around 3'.

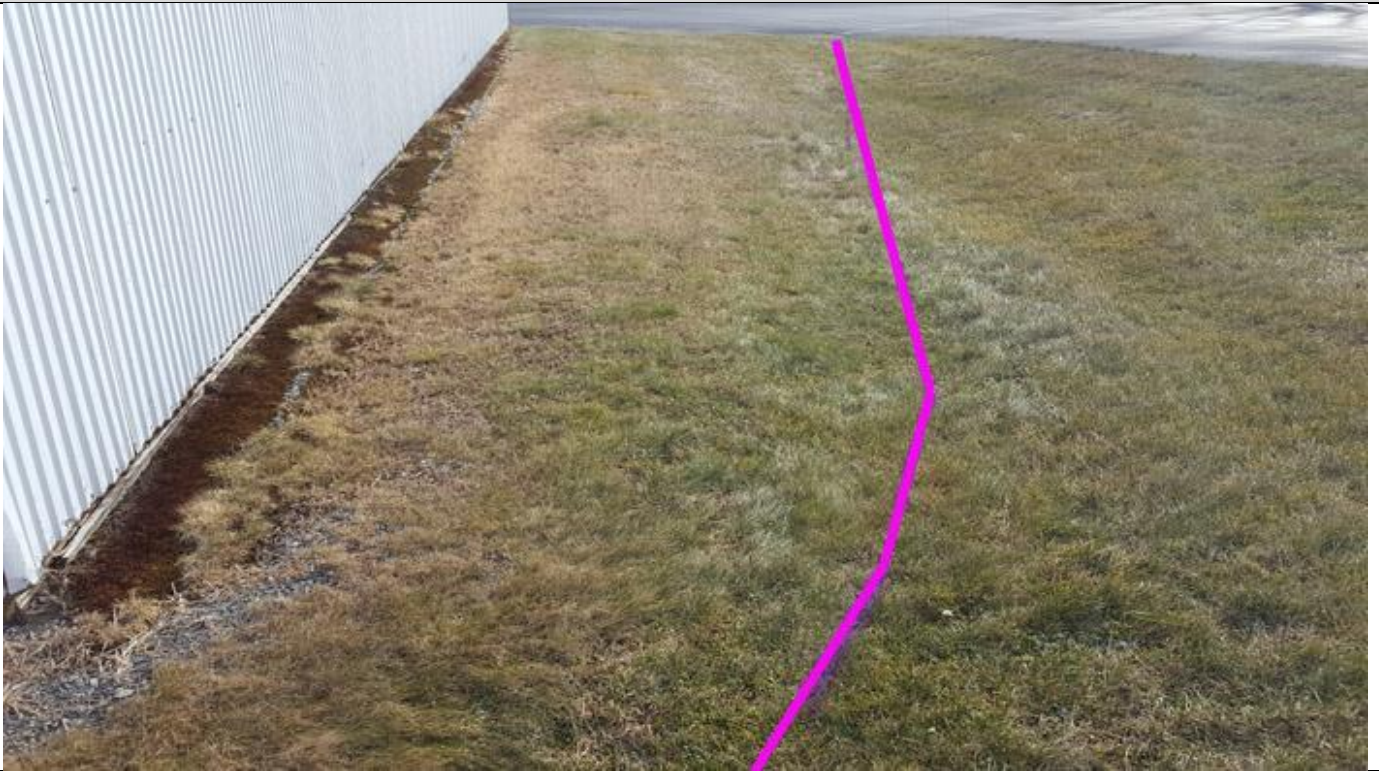
PHOTO 10

South facing photo shows the path of a zone which appears to be a gravel filled trough that conveys wastewater from the septic system to the storm drain in the distance.

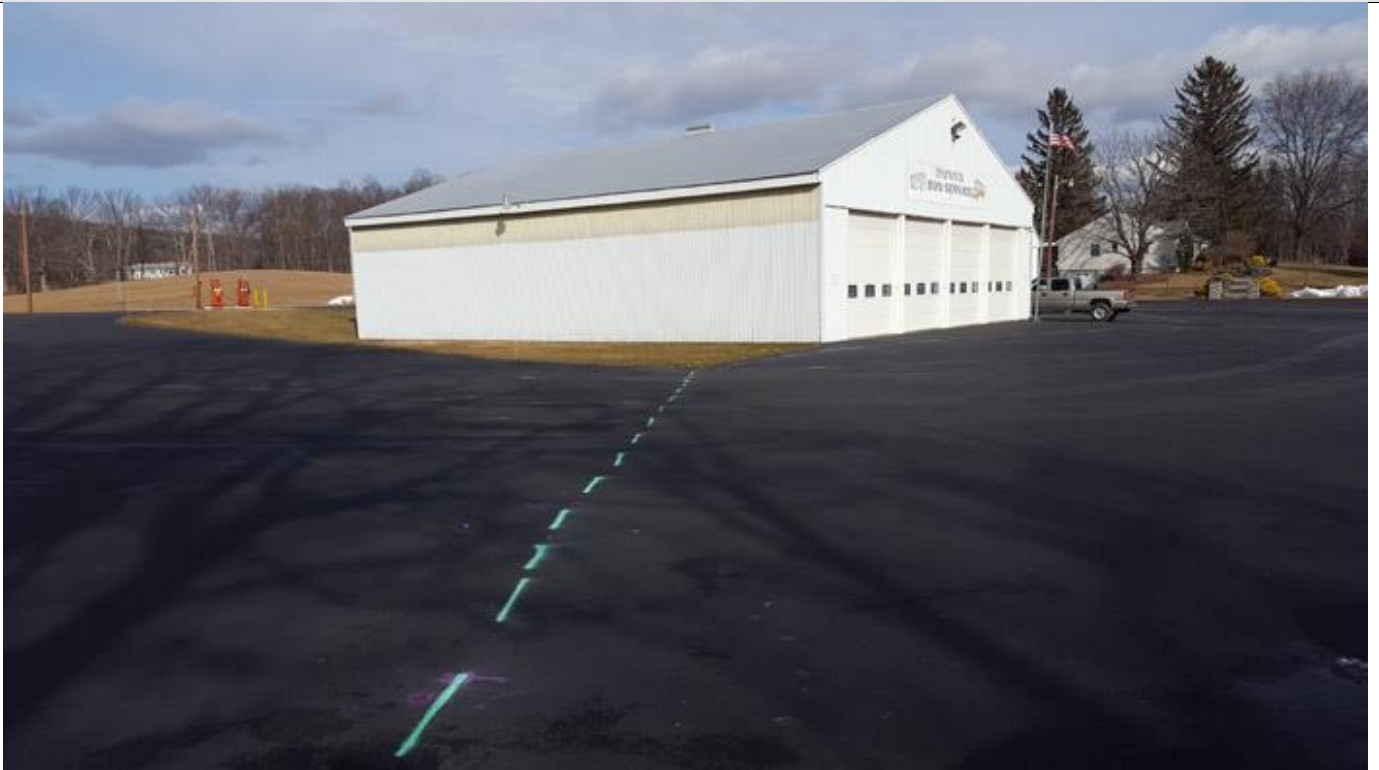
PHOTO 11

Northeast facing photo shows the storm sewer leading from the bus service building to a NW-SE trending creek on the west side of the property.

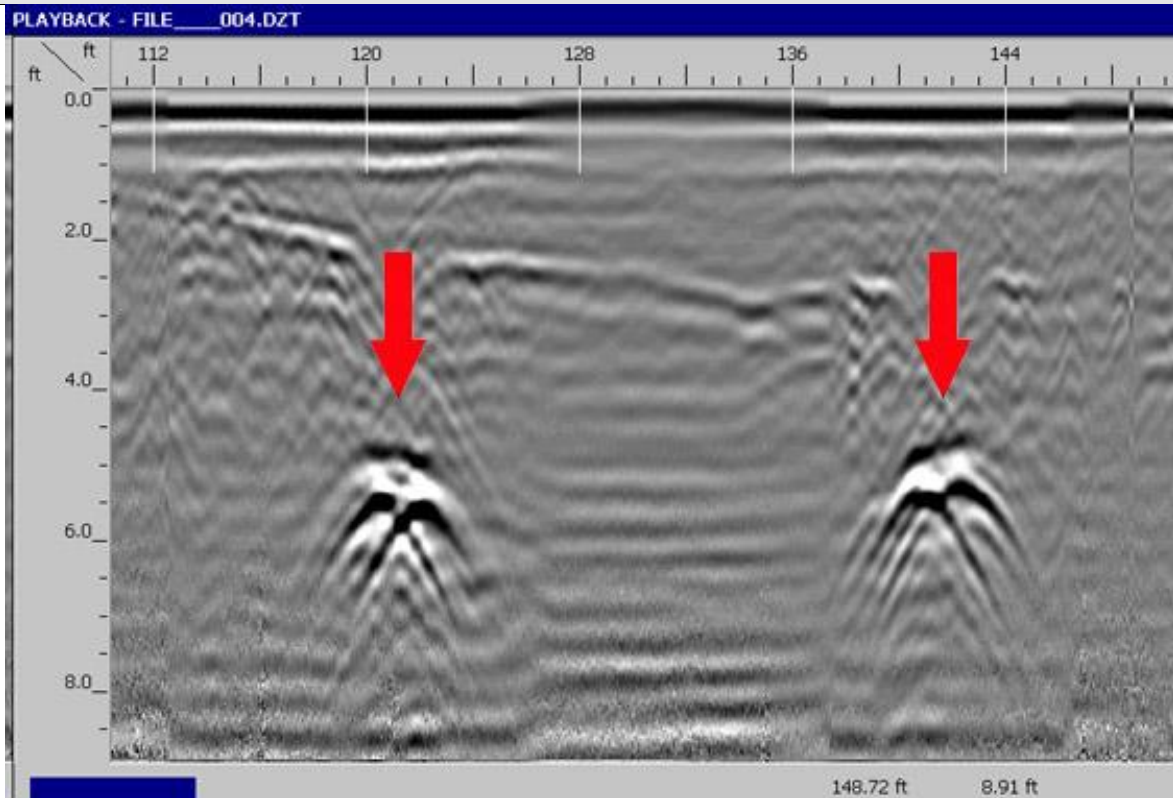
PHOTO 12

GPR transects across the storm sewer line in Photo 11 shows that it sits at a depth of around 5'.

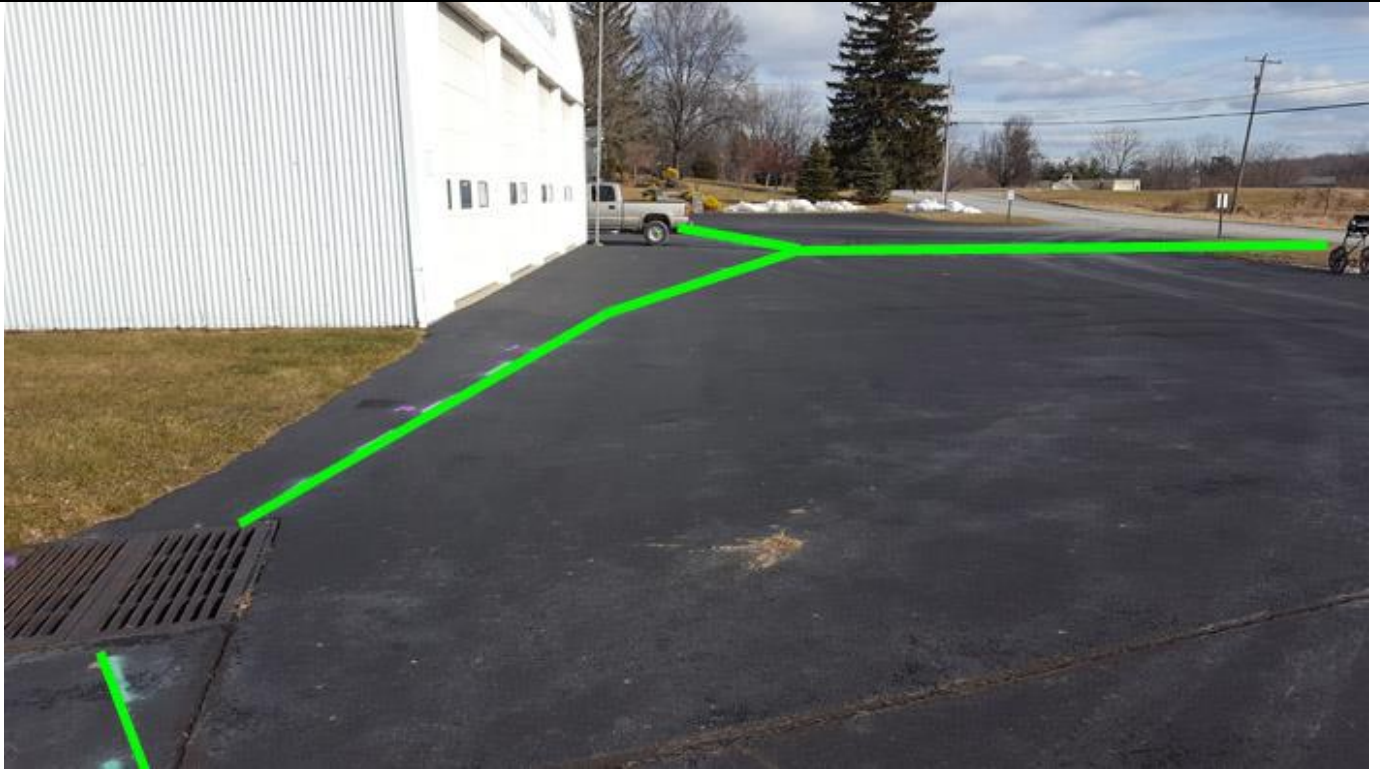
PHOTO 13

Northeast facing photo shows the storm sewer system beneath the asphalt. The sewers sit at depths of 3-4'.

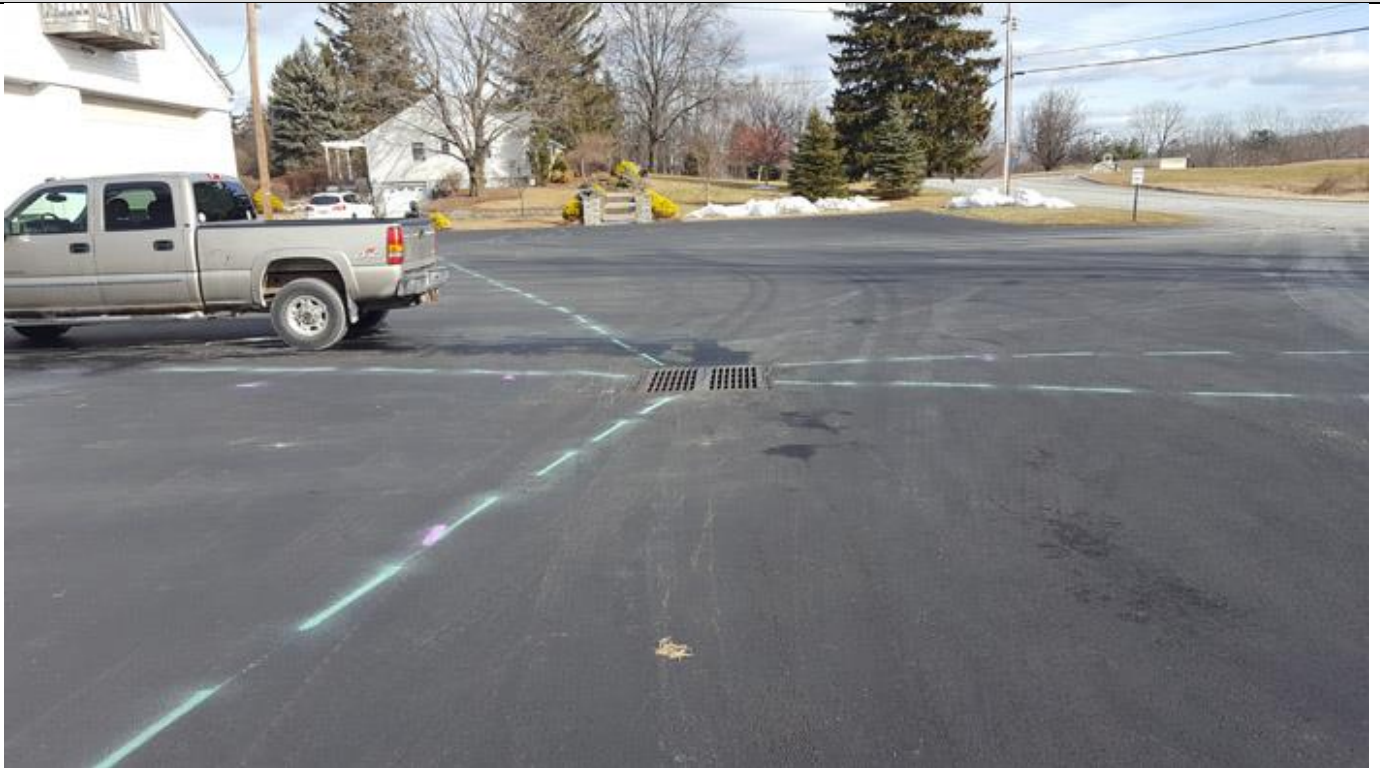
PHOTO 14

Northeast facing photo of the central sewer grate in front of the bus service building where five separate drains converge.

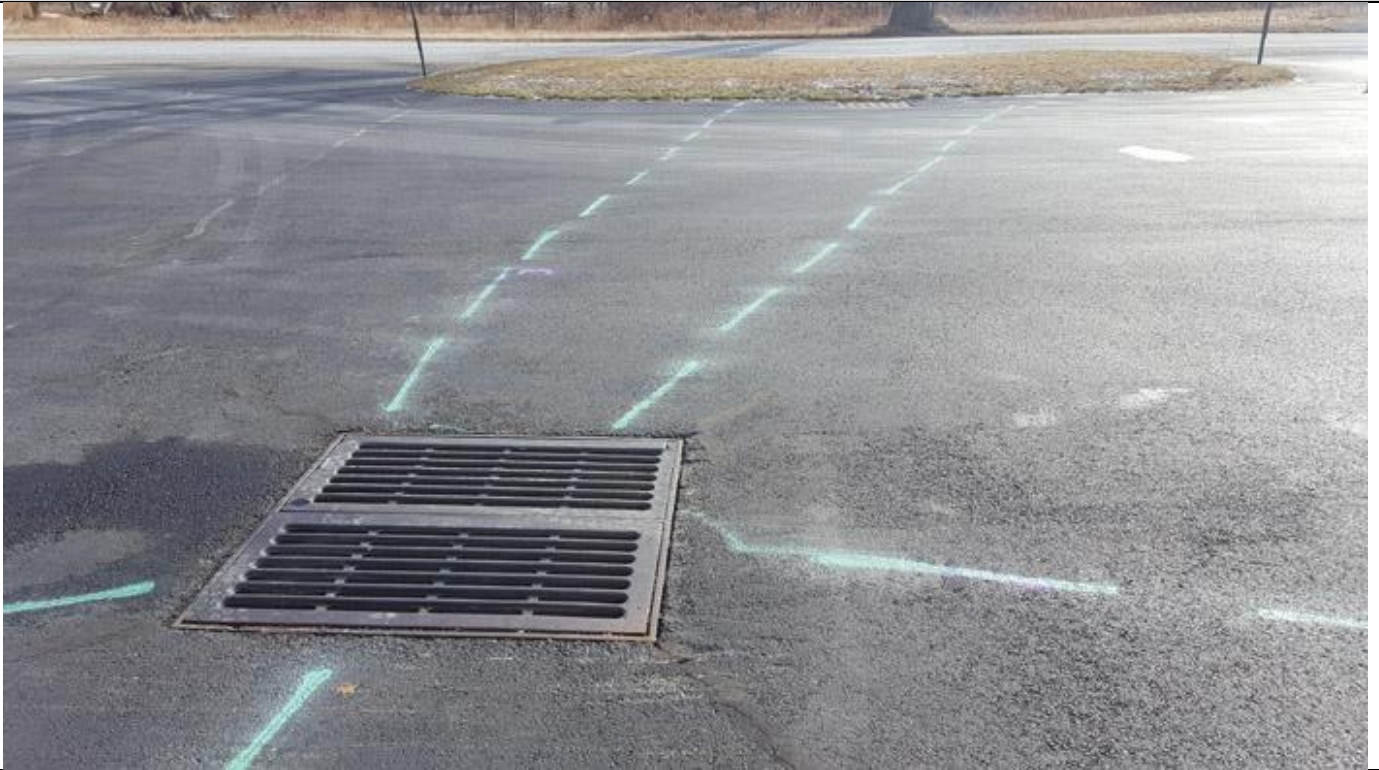
PHOTO 15

Southeast facing photo of the central sewer grate shown in Photo 14.

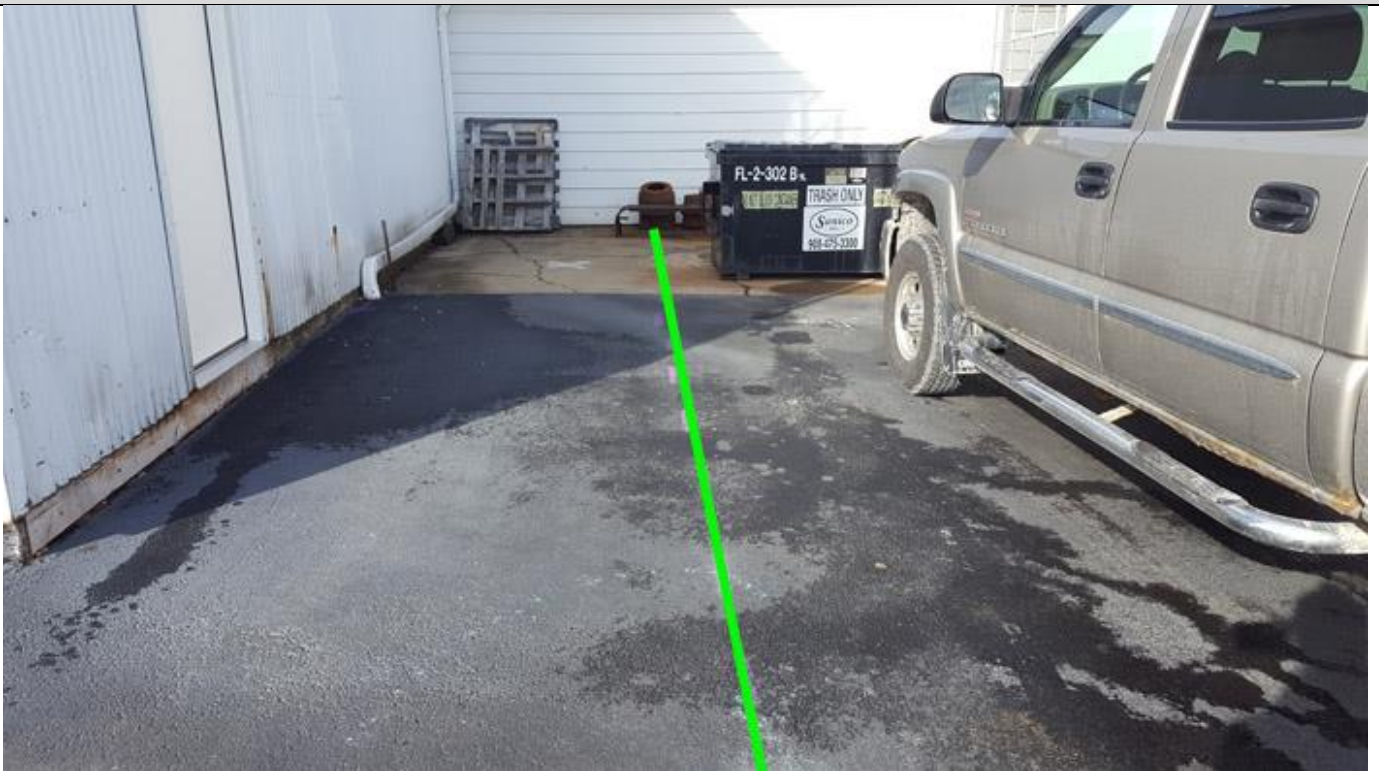
PHOTO 16

Northwest facing photo shows the storm sewer line which passes underneath the building and emerges on the back side.

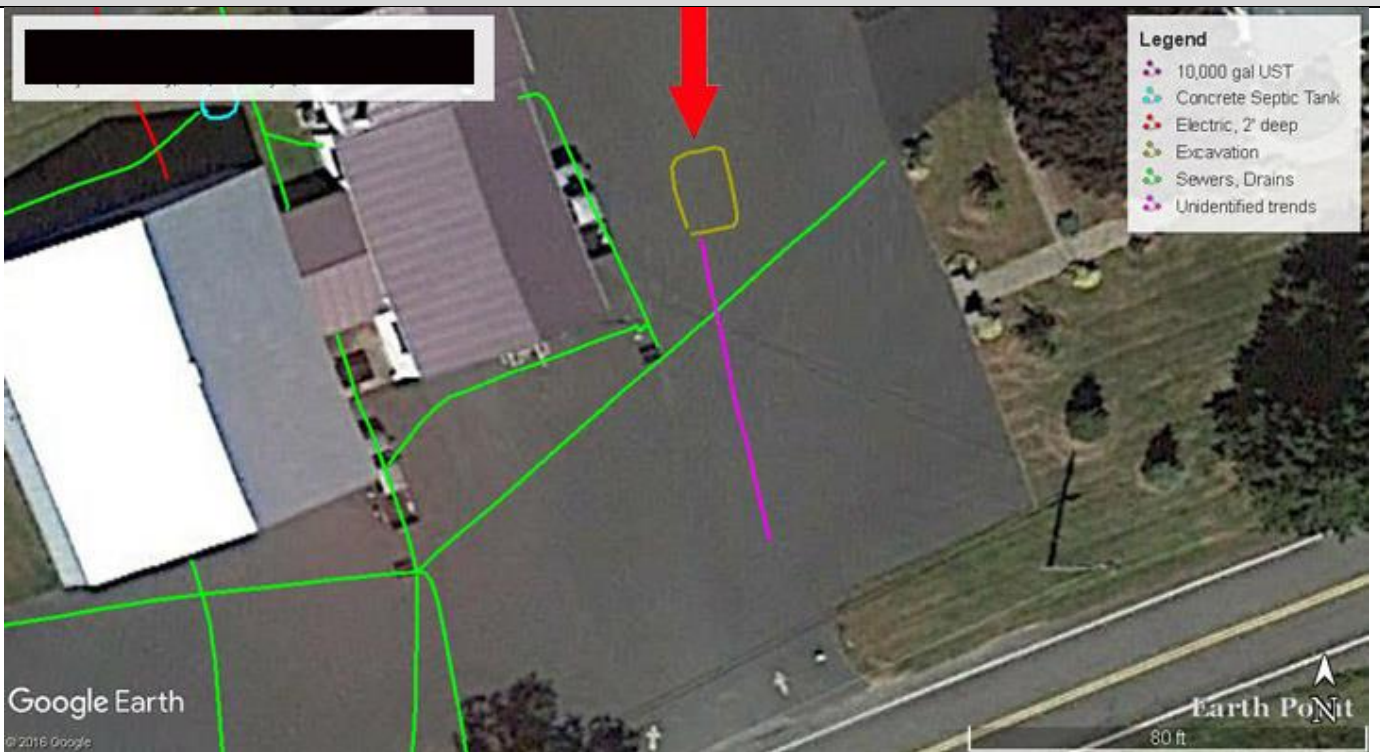
PHOTO 18

On the east side of the building there was a historic oil-water separator and a possible fuel UST, neither of which are still in place. One distinct excavation area was discovered measuring 13'x 10'. The excavation appeared to have steep sides with a strong reflection at 4' and a weak reflection at 2' possibly indicating clay layers associated with the filling of the excavation. A weak trend at a depth of 3' trends south from the excavation. This unidentified feature could be a pipe, possibly a clay pipe. The area to the southeast of the building was scanned with GPR in search of relics from a historic gas station, but no remains of this structure were found.

The red arrow indicates an area measuring 13' x 10' which is an apparent excavation area. The purple line trending south from the excavation is a weak unidentified trend at a depth of around 3'.

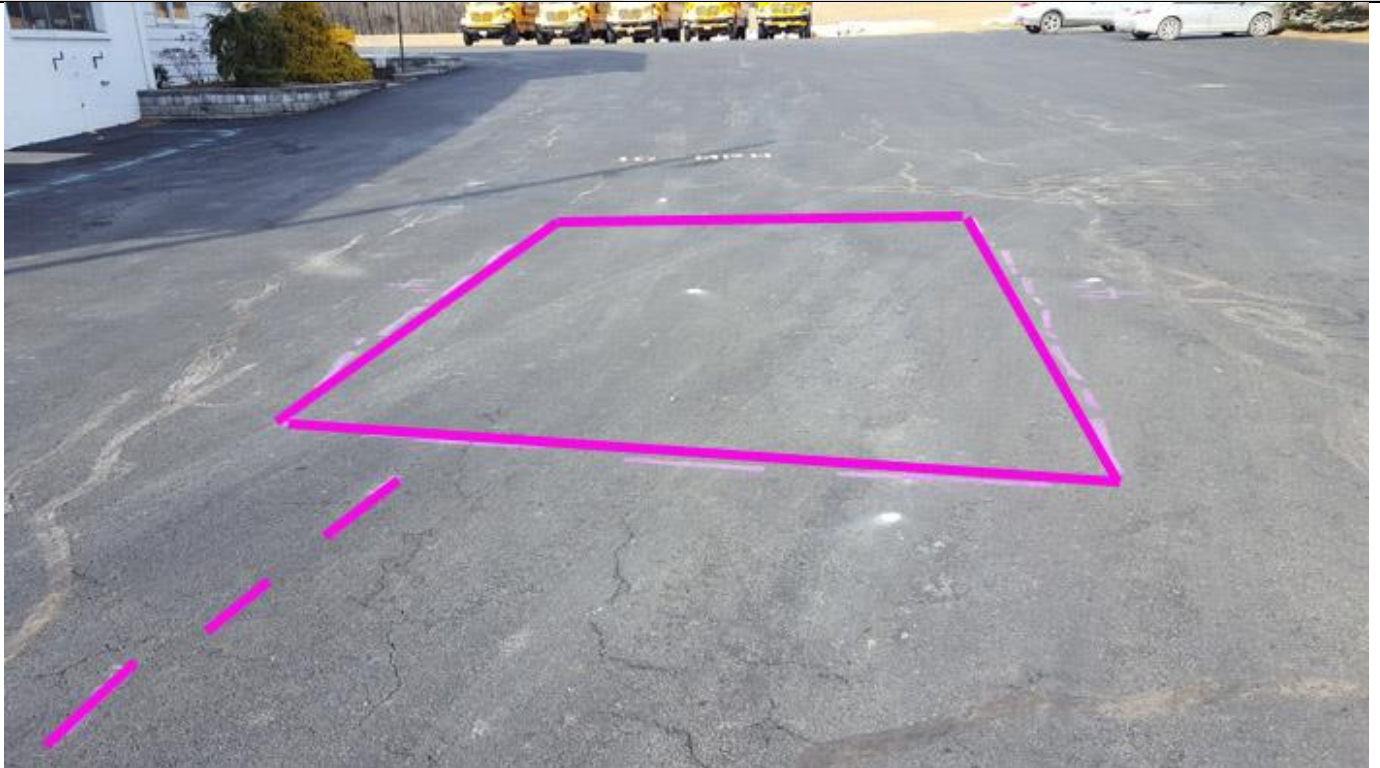
PHOTO 19

Northwest facing photo shows the apparent excavated area from Photo 18 as well as the unidentified trend leading south from that zone.

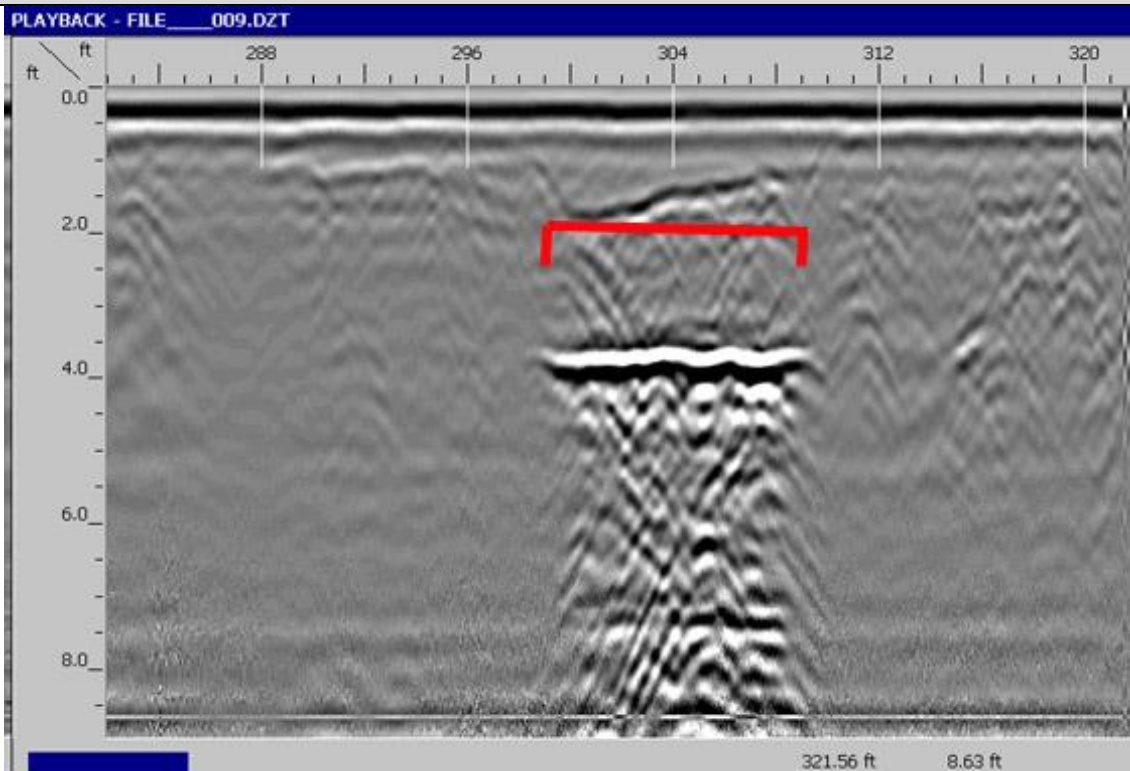
PHOTO 20

GPR transect across the apparent excavated area shows a strong reflection at a depth of 4' which may be a clay layer. A weaker reflection at around 2' may be an additional clay layer.
